OFFICE OF THE INSPECTOR GENERAL

AIRCRAFT FUEL CELL PROCUREMENTS

Report No. 94-001

October 13, 1993

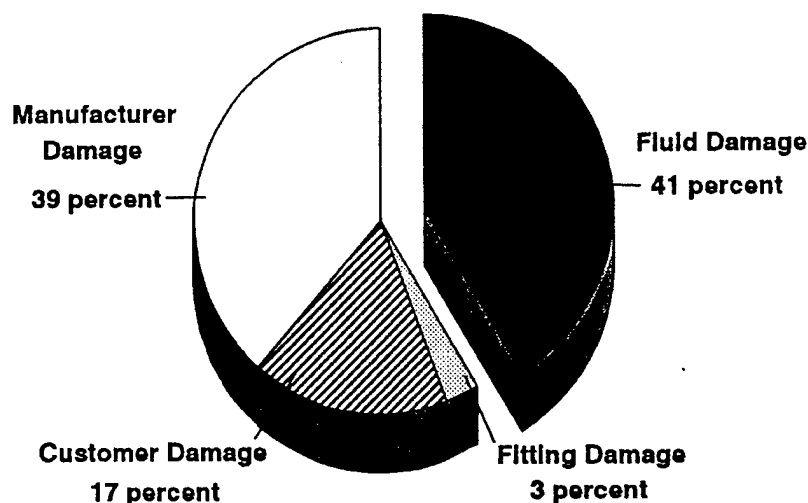
Scope of AH-64 Helicopter Fuel Cell Problem. We took additional steps to determine whether Army users reported the outside delamination problem and whether ATCOM took any corrective action to prevent recurrence. We reviewed a total of 70 QDRs submitted to ATCOM on AH-64 helicopter fuel cell failures between 1986 and 1992. Of the 70 QDRs, 29 (41 percent) of the QDRs were for outside delaminations. An analysis of the QDRs and causes listed for premature failures of the AH-64 helicopter fuel cells is shown in Figure 2.

Figure 2. Quality Deficiencies Reported on AH-64 Helicopter Fuel Cells
